Subject: Permit Issuance Status and Compliance Inspection Summary

CAFO WPDES Compliance Report (September 12, 2012)

Inspection date: September 7, 2012

Operation Name: Kane Family Farm

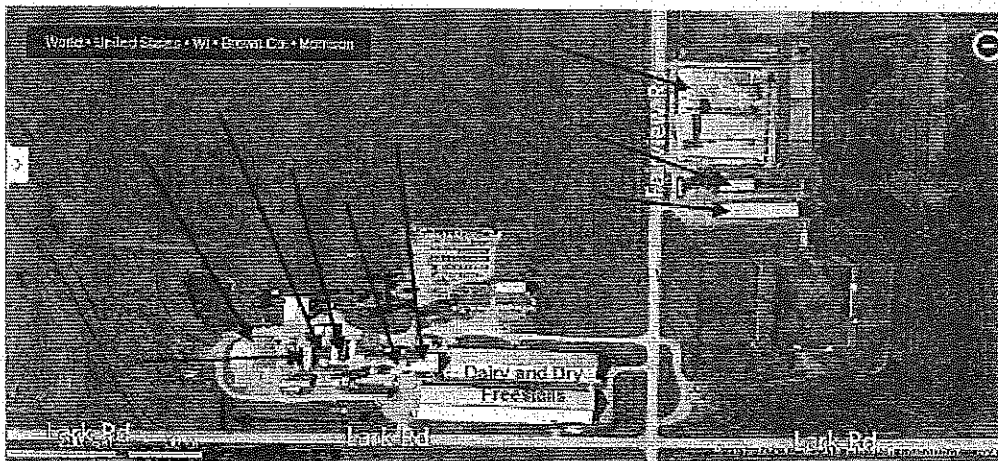
Image 1: Site Overview map of the Main Dairy Facility located at 4367 Lark Road.

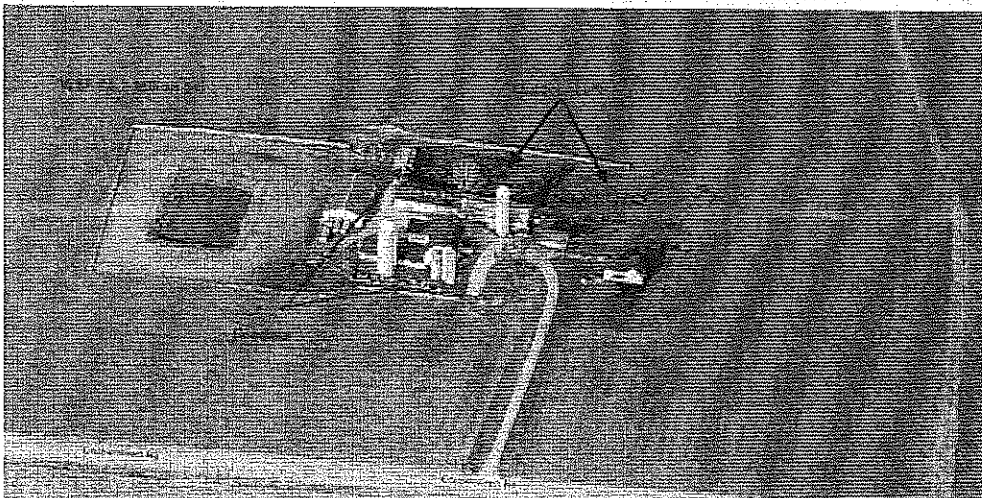
Image 2: Site overview map of the Cooperstown Heifer Site. Cooperstown is the first farmstead on the north side of Cooperstown Rd, west of Fairview Rd.
